U.S. DEPARTMENT OF THE INTERIOR U.S. GEOLOGICAL SURVEY

GEOLOGIC HAZARDS IN THE SUMMIT RIDGE AREA OF THE SANTA CRUZ MOUNTAINS, SANTA CRUZ COUNTY, CALIFORNIA, EVALUATED IN RESPONSE TO THE OCTOBER 17, 1989, LOMA PRIETA EARTHQUAKE: REPORT OF THE TECHNICAL ADVISORY GROUP

Report Prepared for the Federal Emergency Management Agency

U.S. Geological Survey Open-File Report 91-618

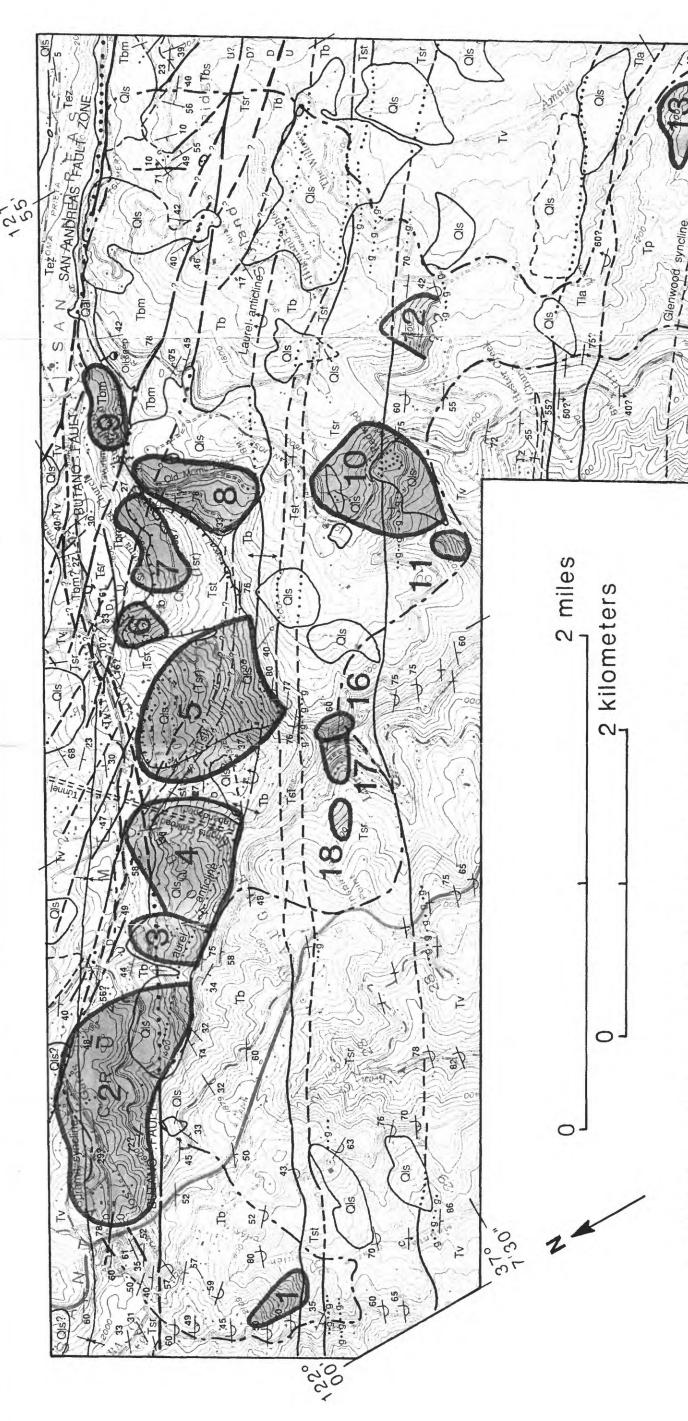
FIGURE 2.4--Geologic map of study area and adjacent parts of Summit Ridge area. Compiled from Clark and others (1989, with landslide boundaries revised by McLaughlin and Clark,1990, unpublished data) and McLaughlin and others (in press). Boundaries of landslides and landslide complexes that moved during Loma Prieta earthquake determined as described in Chapter III of this report.

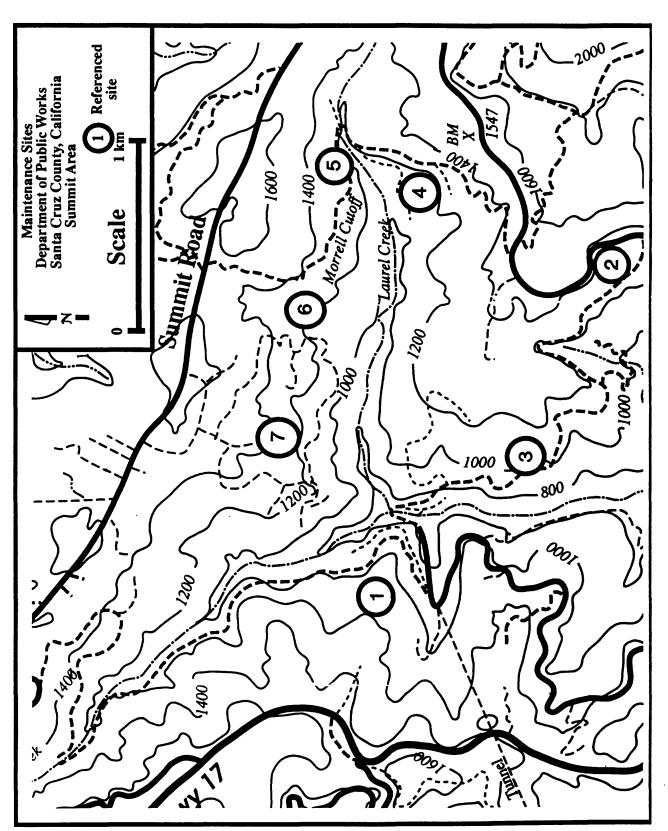
6 Morrell Road--Repeated Damage: Although the area downslope from the 1989 Upper Morrell Road landslide has never been reported as a "problem" area, several stretches of the road have been patched repeatedly. SCC road-repair records did not identify this patching as landslide-related, but the repeated, slow offset of the road, may be related to a larger unstable, landslide feature. Cracks caused by the Loma Prieta earthquake crossed the road in several places. Some cut banks above and below the road have required cribbing and maintenance in the past, evidently because of local road-cut Several of these features failed during the Loma Prieta failures. earthquake.

Villa Del Monte--1975-76 and Repeated Damage: Within the Villa Del Monte area are several areas that have required SCC maintenance, most of which is evidently related to local cribbing or fill failures. In 1975-76, the hillside upslope from Skyview Terrace moved slowly downslope during a period of 2 years. SCC maintenance crews cleared the road approximately once a week during this time. This area is part of the Villa Del Monte landslide complex that moved during the Loma Prieta earthquake.

FIGURE 2.7 -Localities of landslides previous to the Loma Prieta earthquake that were documented by Santa Cruz County Public Works repair records. Locality descriptions in Table 2.2 (modified from Griggs and others, 1990).

types of landslide activity that occurred during the Loma Prieta earthquake. The road repairs were typically associated with cutslope failures, relatively small slumps or slides, or failures involving man-made fill. Seven localities of landslide-related problems were identified (including one just outside the boundary of the study area); these localities are shown on figure 2.7 and described in table 2.2. Even though the types of landslide activity reported were different than those associated with the 1989 earthquake, all seven localities of road damage were also localities where earthquake-induced landslides and (or) ground cracks occurred in 1989.

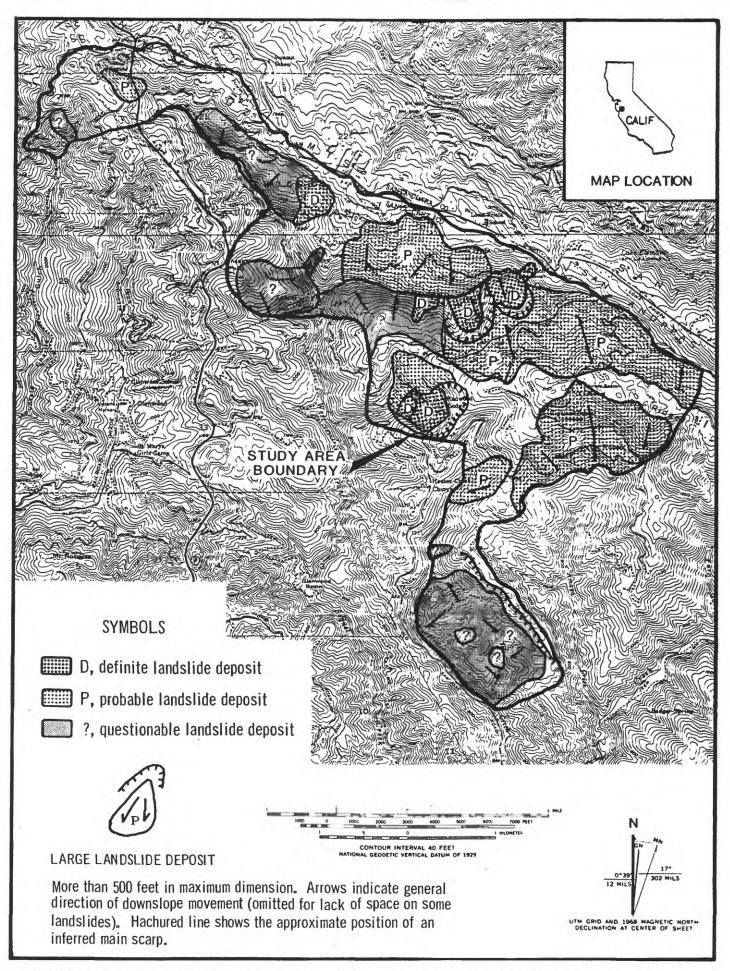
FIGURE 2.8 -Landslide deposits mapped by photointerpretation in the study area (from Cooper-Clark and Associates, 1975).

The map shows 20 large landslide deposits in the study area (fig. 2.8). The largest of these covers more than 0.75 square miles, and together, definite, probable, or questionable landslide deposits cover approximately one-half of the study area. Many of the larger deposits are probably composite features formed over a long period of time by the movement of several, smaller, coalescing landslides and (or) retrogressive, headward growth.

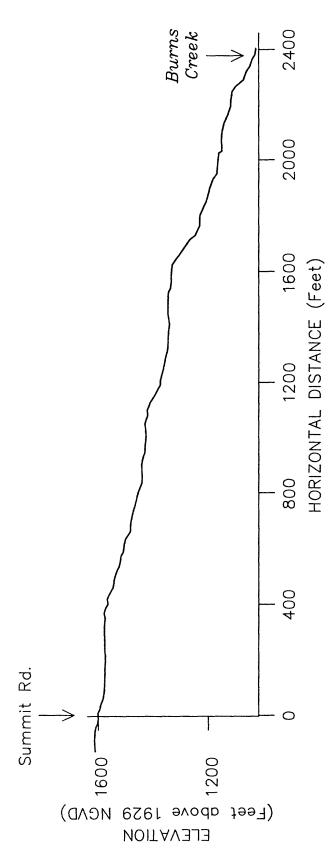
FIGURE 3.3 —— Example of benched topography. Note alternating steep and gently sloping stretches of hillside. Line 3, Upper Schultheis Road area, Surveyed by Majors Engineering, November 18, 1989.

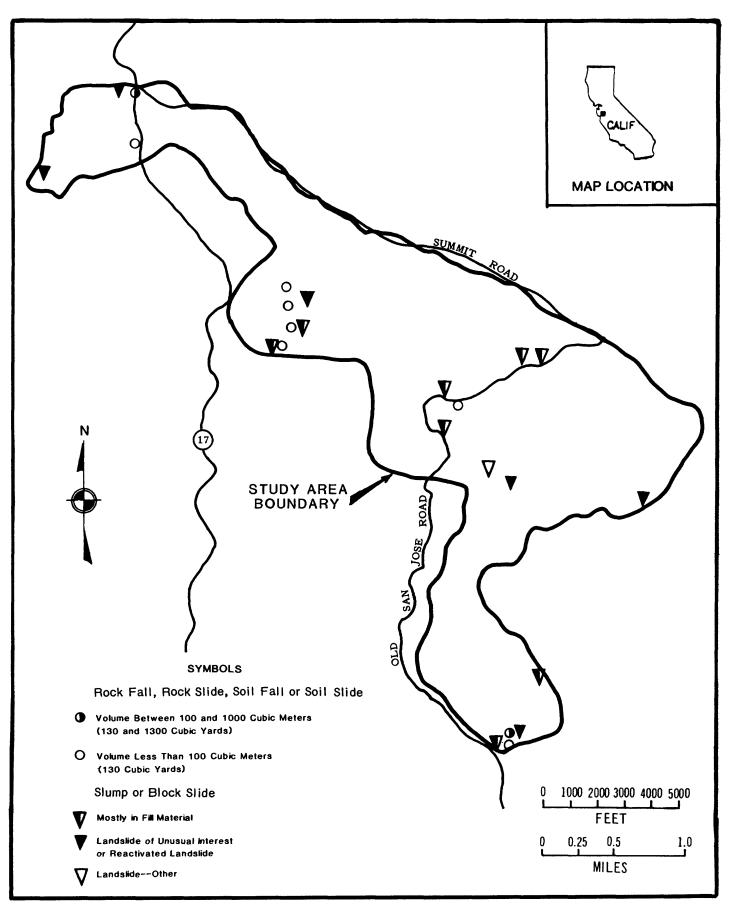
In addition to the 18 large landslides and landslide complexes in the study area, several smaller landslides were triggered during the October 17 earthquake. Some of the smaller slumps and block slides are shown in plates 3.1-3.4. Other smaller, earthquakeinduced landslides in the study area were mapped as part of a region-wide field reconnaissance conducted by CDMG and the USGS, the results of which were compiled by Manson and others (in press). Figure 3.6 shows the locations of those smaller landslides mapped in the study area, most of which were small rock falls, rock slides, soil falls, soil slides, slumps or block slides in fill, or reactivations of older Because these results were compiled from fieldreconnaissance studies only, the available data include only general locations and descriptions of those landslides that were observed on a limited number of traverses through the area. Many other landslides of the types depicted in figure 3.6 probably also occurred in the study area during the earthquake but were not observed or mapped.

FIGURE 3.6 -Smaller landslides in study area triggered by Loma Prieta earthquake. (Modified from Mason and others, in press).

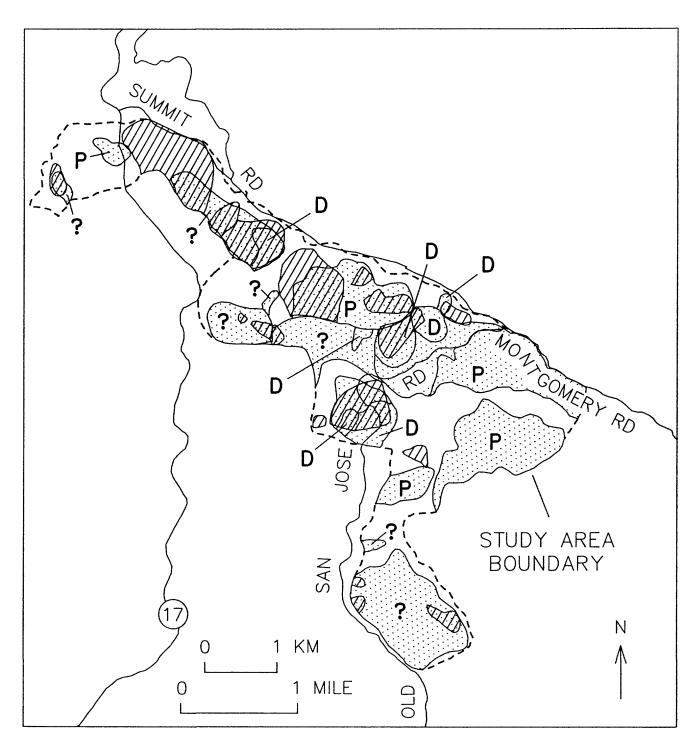
Throughout the study area, locations of landslides and landslide complexes that experienced movement during the Loma Prieta earthquake showed a high correlation with locations of large, preexisting landslide deposits, as mapped by Cooper-Clark and Associates (1975). Of the 18 large landslides and landslide complexes that moved during the earthquake, all but one or two were wholly or partly within areas designated as "definite," "probable," or "questionable" landslide deposits on the 1975 map (figs. 2.8 and 3.7). The two exceptions were among the smaller of the earthquake-related landslides, with areas of 11 and 5 acres, and the possible downslope extension of one of them was within a "probable" landslide deposit, identified on the 1975 map. Of the 16 or 17 earthquake-related landslides and landslide complexes that occurred within landslide deposits depicted on the 1975 map, four were wholly or partly within "definite" landslide deposits, four or five were within "probable" deposits, 10 were within "questionable" deposits, and one was within a deposit that was not labeled. (Some of the earthquake-induced landslides were associated with more

FIGURE 3.7 — Generalized boundaries of landslides and landslide complexes inferred to have moved during the Loma Prieta earthquake (areas of diagonal stripes) compared to generalized landslide deposits and scarp areas (dotted patterns) mapped by Cooper — Clark and Associates (1975); D designates "definite", P "probable", and ? "questionable" landslide deposits and associated scarp areas as portrayed on 1975 map.

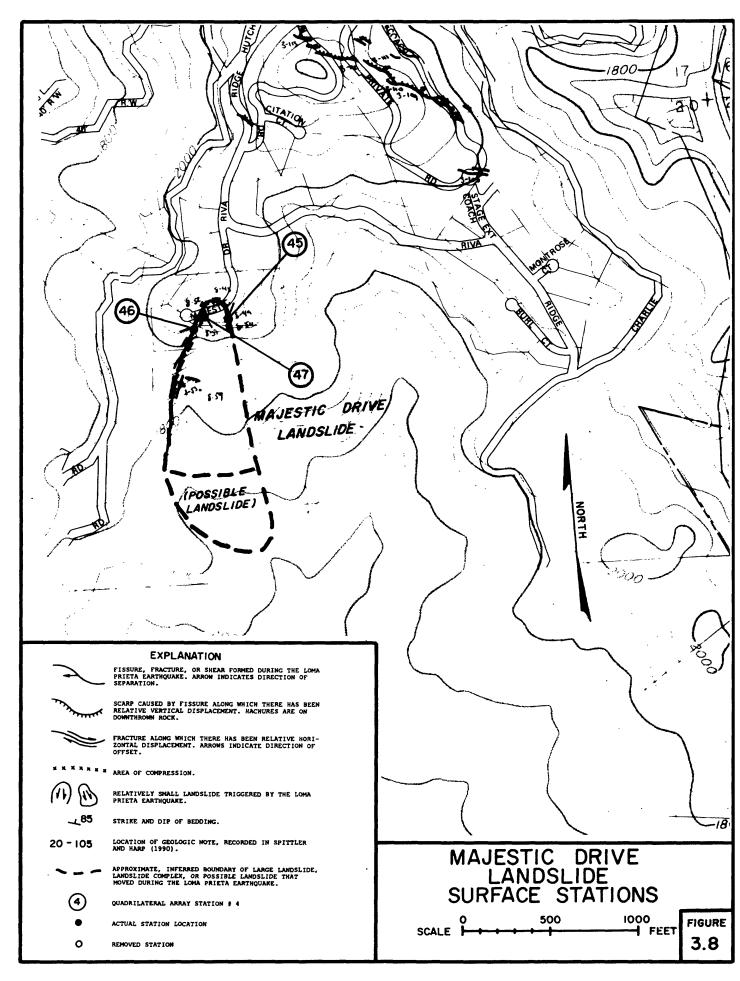
The Majestic Drive landslide is at the southern end of a spur ridge, which branches off Summit Ridge 0.6 miles southwest of the intersection of Summit Road and California Highway 17 (plate 3.1 and fig. 3.8). The crown, head, right flank, and uppermost left flank of the landslide are defined by a relatively continuous, 10- to 40-foot-wide zone of scarps and cracks that is arcuate, concave downslope in plan view. Downslope displacements across individual scarps and cracks at the head of the landslide were more than one foot.

The zone of cracks and scarps on the right flank of the landslide extends downslope approximately 1,000 feet, and the landslide mass is inferred to extend at least as far down the ridge flank as the downslope margin of this zone. As delineated on plate 3.1 and figure 3.8, the landslide mass is at least 1,000 feet long and 300 to 550 feet wide and has a surface area of at least 8 acres. The locations of the toe and lower left flank of the landslide, however, are uncertain, as no surface features marking their locations were mapped. Because no surface features marking a toe were evident, the landslide could extend an additional 400 feet farther downslope to the creek channel at the base of the ridge. The area between the downslope margin of the surface cracks and the creek channel is thus designated as a "possible landslide" in plate 3.1 and figure 3.8 and may encompass an additional area of 5 acres.

The average slope of the ridge flank down which this landslide moved is 20°; this slope also has a benched profile, with the several

gently sloping benches suggesting previous landslide movements. All but the uppermost part of the Majestic Drive landslide involves material previously designated by Cooper-Clark and Associates (1975) as belonging to a "questionable" landslide deposit (fig. 3.7).

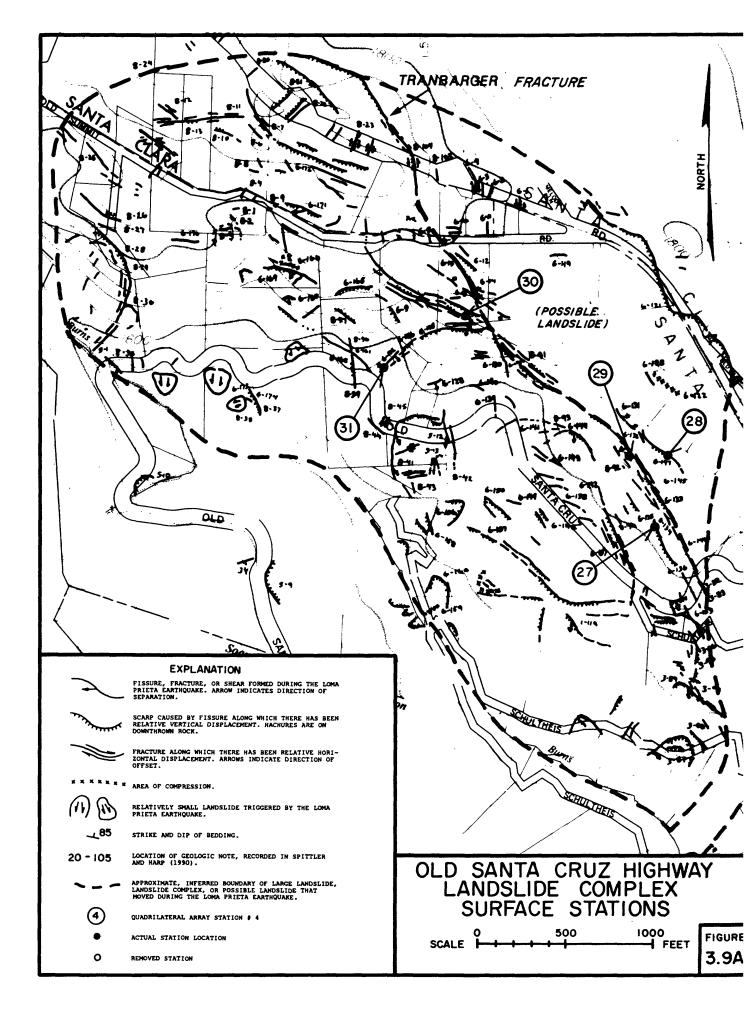
The Old Santa Cruz Highway area (plate 3.1 and fig. 3.9) encompasses a zone of complex earthquake-induced landslides and structurally controlled cracks on the crest and south flank of Summit Ridge, extending 1 mile eastward from a point 1,000 feet east of the intersection of California Highway 17 and Summit Road. Downslope from near the ridge crest to Burns Creek, the zone of cracks and landslides extends for approximately 2,200 feet and thus encompasses approximately 0.33 square miles (210 acres).

Downslope and southwest of the two major zones of cracking are numerous, shorter, arcuate scarps and cracks and other features that indicate the presence of several smaller and shallower landslides (plate 3.1 and fig. 3.9). These scarps, cracks, and other features, which include localized areas of compression or bulging ground, are so numerous as to form a virtually continuous landslide complex between the "Tranbarger fracture" and Burns Creek. This area is thus designated as a "landslide complex" in plate 3.1 and figure 3.9, whereas the area between the two long crack features is designated as a "possible landslide."

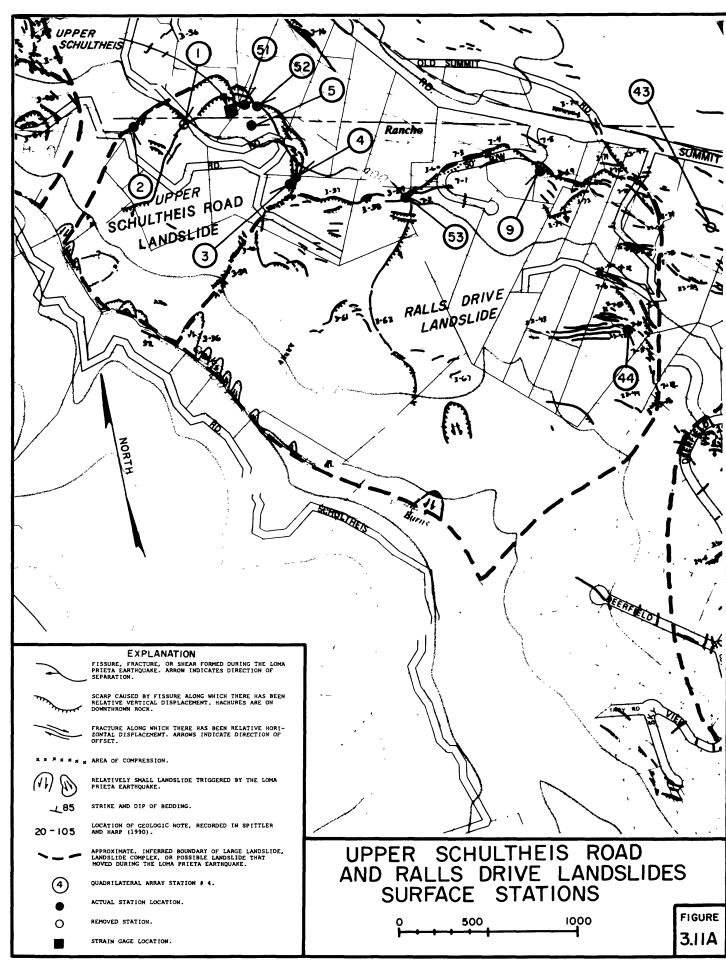
The crown, head, and upper western flank of the landslide are delineated by a continuous, complex main scarp that is arcuate and concave downslope in plan view (plate 3.1, figs. 3.11 and 3.12). The eastern flank of the landslide is marked by a set of discontinuous

Two of three known water wells within the landslide were reported to have been damaged during the earthquake. In well #218, along the right flank (fig. 3.11), an offset of 8 to 12 inches was reported to have occurred at a depth between 14 and 16 feet in a 30-inch-diameter casing; in well #141 (fig. 3.11), along the left flank, the pump motor was reportedly broken off the pump and the motor shaft bent to a 90°-angle at a depth of 97 feet (Brumbaugh, 1990).

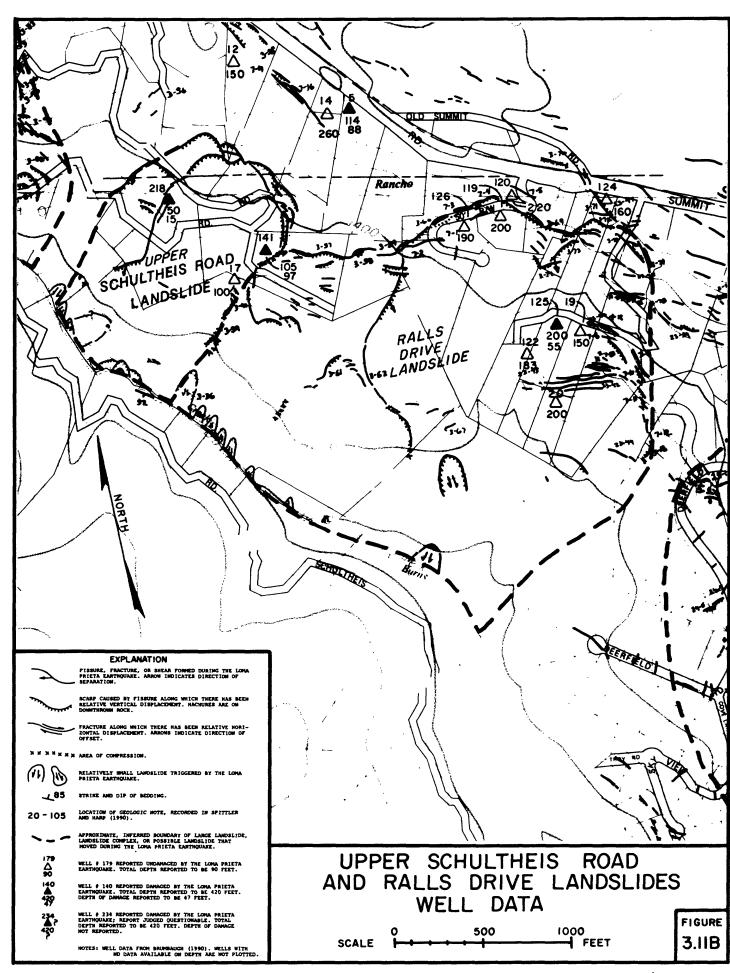
FIGURE 3.12 -Segment of arcuate, concave-downslope, ground-crack and scarp feature that forms the main scarp of the Upper Schultheis Road landslide. Photograph taken near crown of landslide; view is toward the east. Measurements near this locality showed 42 inches of extensional displacement and 18 inches of vertical displacement across this main scarp.

Displacements measured along a transect across the main scarp indicate that the head of the Upper Schultheis Road landslide moved 46 inches downslope. An additional 51 inches of total downslope displacement was measured across a series of internal fissures and scarps, striking approximately parallel to the slope contours, that extended 203 feet downslope from the main scarp. Measured displacement of landslide material was thus 97 inches (8.1 feet) (R. W. Jibson and D. K. Keefer, 1989, unpublished data).

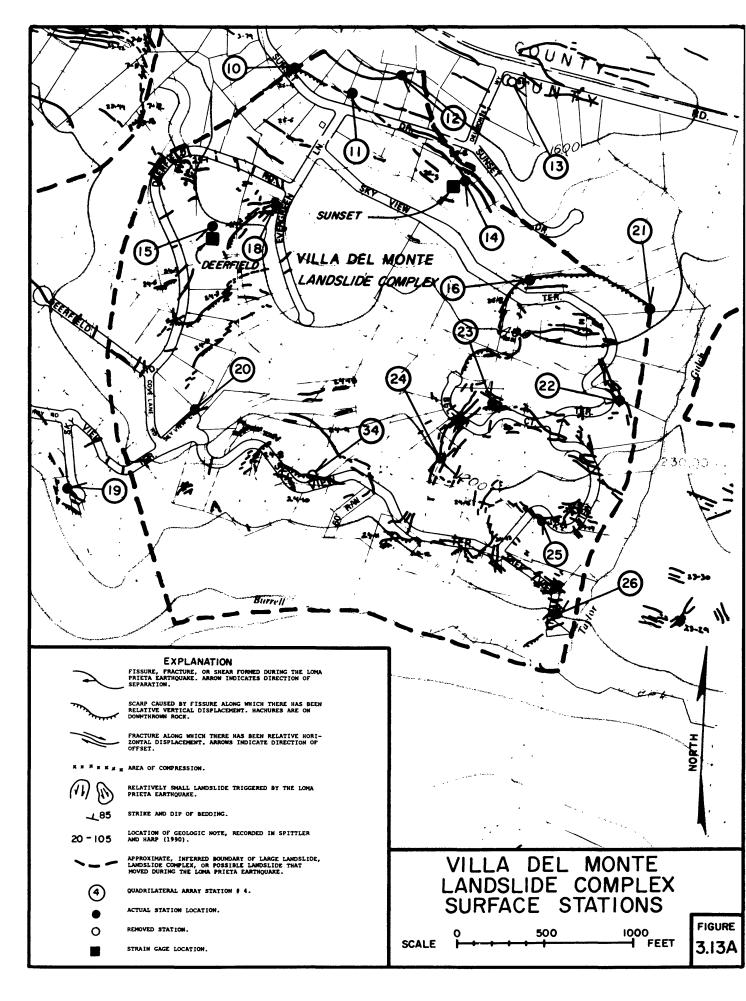
The Villa Del Monte landslide is on the south flank of Summit Ridge, on the broad spur ridge between the Ralls Drive landslide and Taylor Gulch (plate 3.1 and fig. 3.13). Topographic profiles surveyed down the ridge flank in this area show average slope inclinations of between 12° and 15°, with numerous gently sloping benches alternating with steeper stretches of slope, especially in the central and eastern parts of the area. Slopes immediately upslope from Laurel (Burrell) Creek, at the base of the ridge, in particular, are relatively steep. Numerous roads and building sites have been located in this area to take advantage of the gently sloping benches, and the Villa Del Monte neighborhood, which contains approximately 165 homes, is the most densely populated part of the Summit Ridge area.

cracks are along Sunset Drive, in the area of upper Skyview (or "Sky View") Terrace and Bel Air (or "Belair," "Bel-Air," or "Bel Aire") Court, along and east of Deerfield Road, and along lower Skyview Terrace (plate 3.1 and fig. 3.13). Additional, smaller zones of ground cracks along the westernmost extension of Deerfield Road and around the Troy Road-Skyview Terrace intersection (fig. 3.13) are probably associated with separate, smaller landslides.

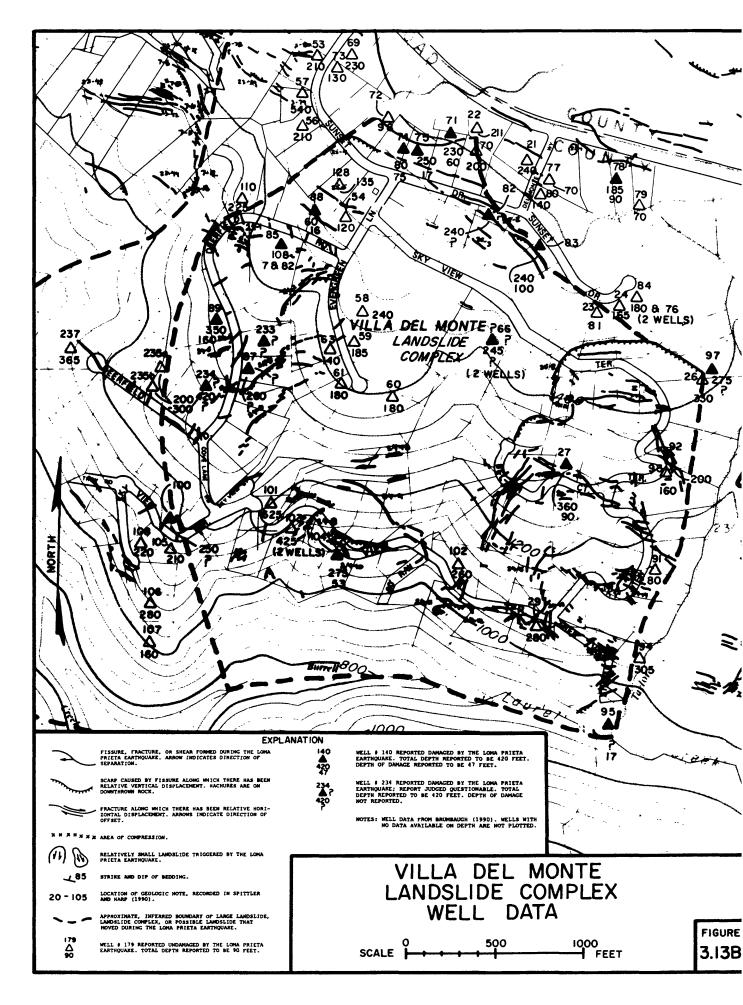
Sunset Drive area: Cracks and scarps in the Sunset Drive area (figs. 3.13 and 3.14) extend approximately 1,400 feet across the slope; they cross Sunset Drive west of Evergreen Lane and again between Evergreen Lane and Del Monte Way (plate 3.1 and fig. 3.13), and they extend downslope from above Sunset Drive to near the Deerfield Road-Evergreen Lane intersection. Individual cracks and scarps are linear, arcuate and concave-downslope, or, in one case, concave-upslope in plan view. For part of its length, this zone of cracks and scarps crosses a gentle slope immediately downslope from a 9- to 15-foot-high bedrock scarp composed of intensely fractured Displacements measured across individual cracks and sandstone. scarps in this zone were downslope toward the southwest and southeast and were in the range between 3 and 21 inches (fig. 3.13). Whereas cracks and scarps in this area exhibit characteristics associated with a landslide, such as overall concave-downslope curvature of the zone in plan view and downslope displacements, a few northwest-striking cracks are also subparallel to local faults (fig. 2.4) and thus may also have been structurally controlled.

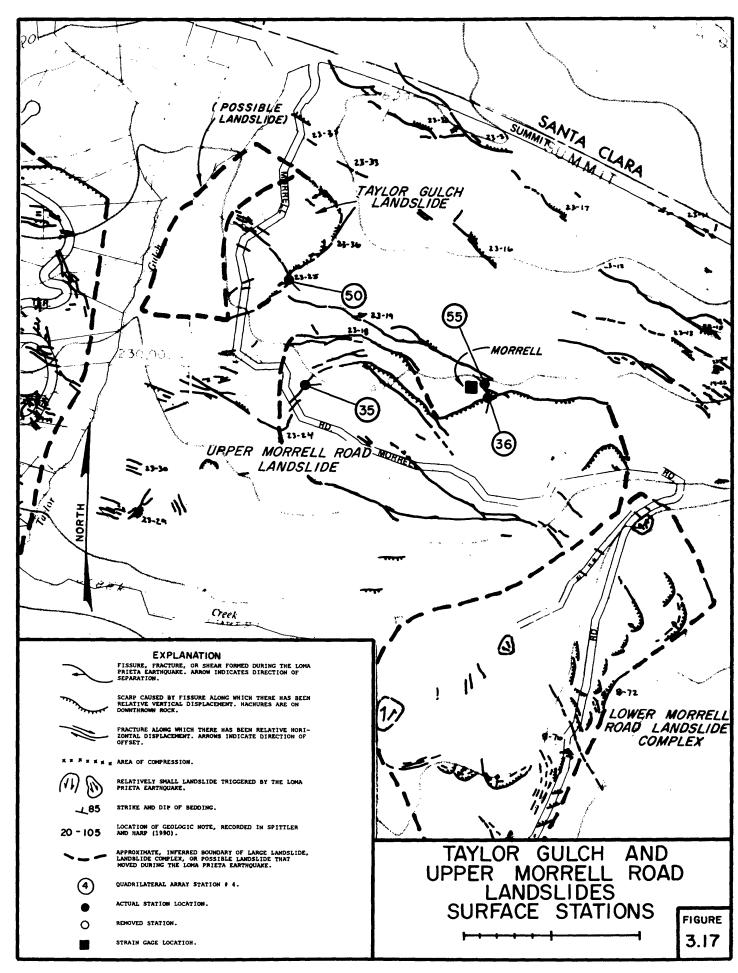
The Taylor Gulch landslide is on the east side of Taylor Gulch, which cuts into the southwestern flank of Summit Ridge. The landslide crosses Morrell Road (or "Morrill Road," or "Morrell Cutoff") 600 to 1,500 feet south of the Morrell Road-Summit Road intersection (plates 3.1 and 3.2 and fig. 3.17).

The crown, head, and flanks of the landslide are defined by an arcuate, concave-downslope scarp, 800 feet long, upslope from and east of Morrell Road (plates 3.1 and 3.2 and fig. 3.17); a discontinuous zone of cracks extends an additional 400 feet along the southern flank of the landslide. One displacement measurement across the main scarp indicated movement of 21 inches downslope, to the west. The landslide is disrupted by one zone of northwest-striking internal cracks, which are subparallel to unnamed faults mapped through this area (fig. 2.4) and which therefore may have been structurally controlled.

The toe of the landslide is not delineated by any observed surface feature, and so the downslope extent of the landslide can be inferred only within wide limits. The landslide is inferred to extend downslope at least as far as the downslope limit of ground cracking (fig. 3.17), and it is possible that the landslide extends downslope to the bottom of Taylor Gulch. The landslide is thus at least 900 feet wide and 500 feet long and covers at least 6 acres; if it extends to the

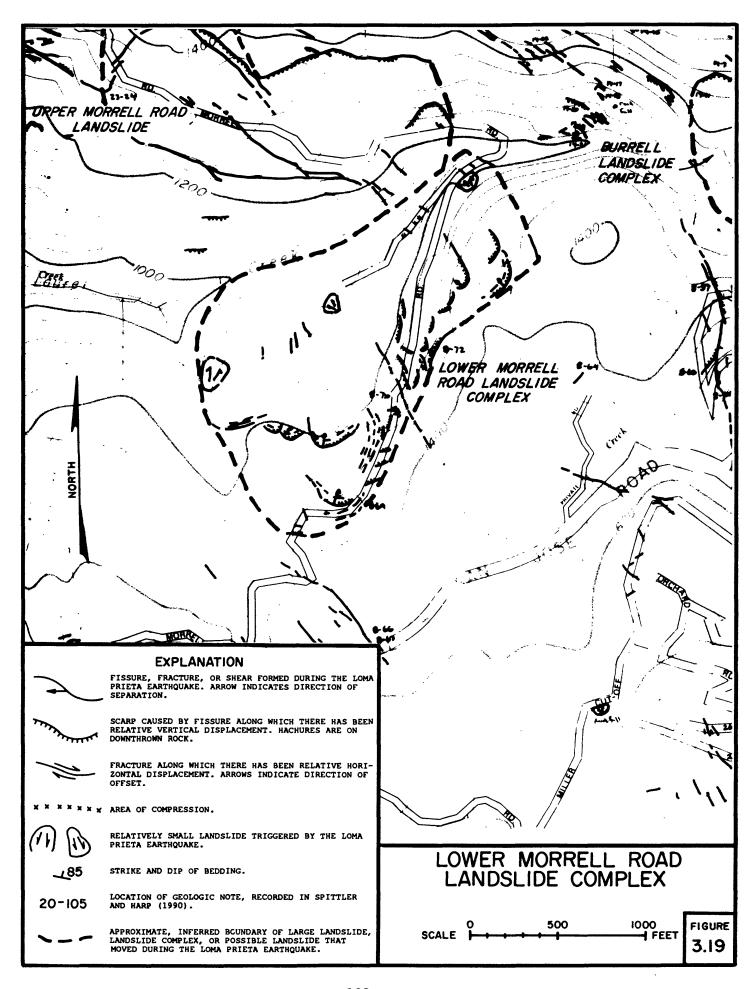
This landslide complex stretches along Morrell Road, 0.6 to 0.9 miles southeast of its intersection with Summit Road. The complex contains many scarps and cracks, some of which occur in zones as much as 100 feet wide (plate 3.2 and Fig. 3.19). The longest scarps are arcuate, concave-downslope; some of the shorter scarps and cracks are more linear. The complex also contains at least three smaller, completely defined landslides. Together, scarps and other features delineate a landslide complex, approximately 1,500 feet long and 2,200 feet wide, that extends downslope from the prominent zone of scarps adjacent to Morrell Road to the creek at the base of the slope, encompassing an area of 54 acres. Displacements measured across individual scarps and cracks were as much as 13 inches; because the slope morphology and patterns of cracking indicate that the landslide complex is composed of many units, the

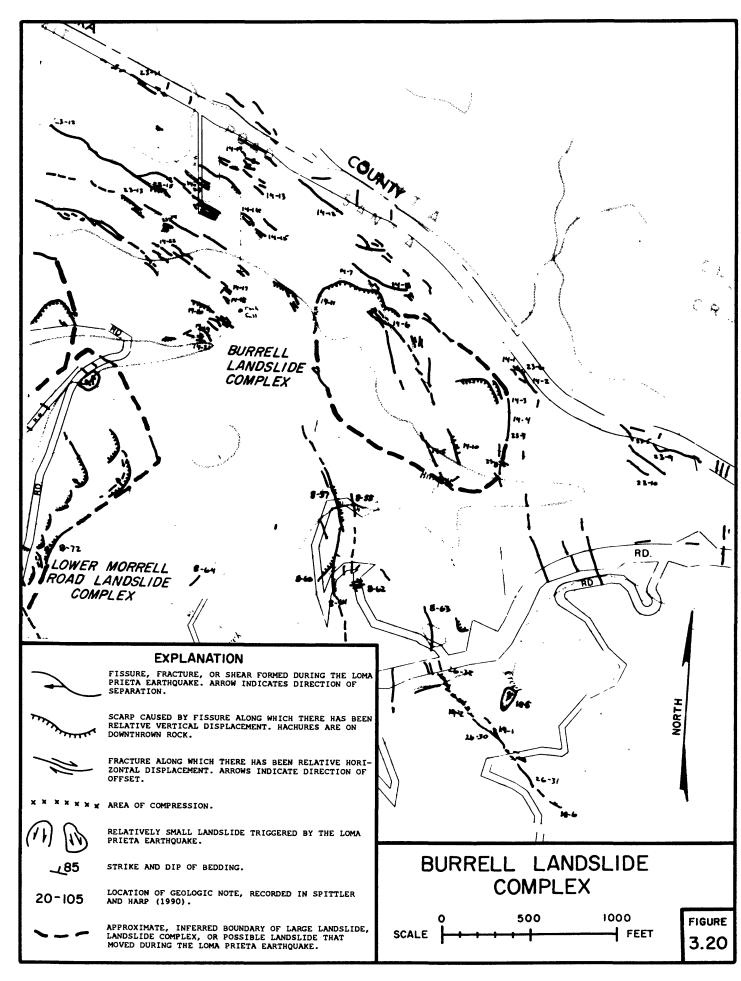
The Burrell landslide complex is on the south flank of Summit Ridge, 300 feet south of the Summit Road-Loma Prieta Avenue intersection (plate 3.2 and fig. 3.20). Scarps interpreted as landslide features within the complex were differentiated from other cracks in this area, interpreted as having been structurally controlled and formed by other processes, based on arcuate (vs. linear) form, occurrence at the upslope margin of a gently sloping topographic bench, and the occurrence of local compression features downslope from the arcuate scarps. The heads of two main landslides in this complex were thus delineated by two arcuate, concave-downslope scarps, which are separated by a zone of discontinuous cracks (plate 3.2 and fig. 3.20). A local compression feature downslope from the western margin of one of the arcuate scarps (locality 14-11 on plate 3.2 and fig. 3.20) delineates a portion of the landslide toe. Elsewhere the position of the toe is not marked by surface features, but the trend and location of the landslide-related features suggests that the complex may extend downslope to the channel of Laurel Creek. The complex is thus approximately 750 feet long and 1,500 feet wide and

encompasses approximately 22 acres. Downslope displacements measured across the major scarps were in the range between 11 and 28 inches.

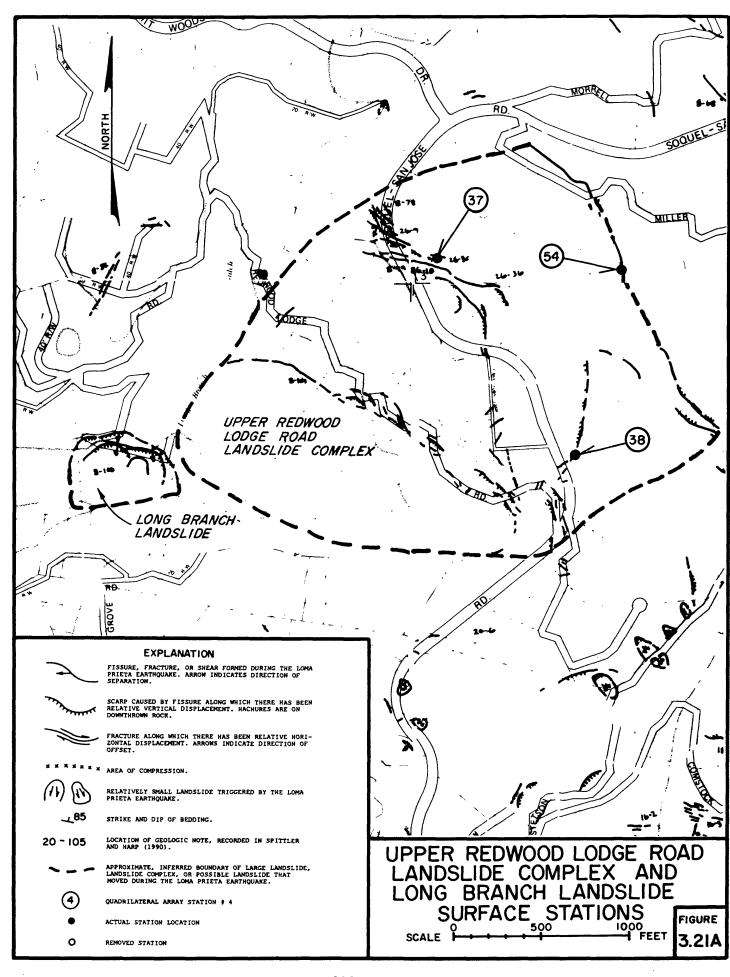
The Upper Redwood Lodge Road landslide complex is in the Redwood Lodge area. The landslide crosses Old San Jose ("San Jose-Soquel") road between Summit Woods Drive and Redwood Lodge Road, 1.2 miles south of Summit Road (plates 3.1-3.4 and fig. 3.21).

The zone of cracks and scarps next downslope crosses Old San Jose Road approximately 1,800 to 2,000 feet north, 1,100 feet north, and 300 feet north of its intersection with Redwood Lodge Road (fig. 3.21). This zone forms an arcuate pattern, concave downslope in plan view. The southern part of this zone is at the base of an older bedrock scarp, and the slope between this zone and the creek channel to the west has a benched topographic profile. Both the older scarp and the benched profile are additional indicators of previous landslide movement. Direct evidence of previous landslide movement at this locality was also documented by SCC road-repair records that describe repeated landslide damage to Redwood Lodge Road (table 2.2 and fig. 2.7). Earthquake-related displacements of 1 to 12 inches measured across individual cracks in this zone were not consistent in direction.

The zone of cracks and scarps farthest downslope trends westnorthwest along and downslope from Redwood Lodge Road, between Old San Jose Road and Long Branch Gulch (fig. 3.21). This zone, which is 1,900 feet long, is the most continuous of the three main zones of cracks and scarps in the landslide complex.

Two wells within the boundaries of the landslide complex were reported to have been damaged by the earthquake--well #159, at a depth of 90 feet and well #38, at an unknown depth--while four wells (#35, 36, 37, and 40 in fig. 3.21), with depths between 150 and 370 feet, were reported to have been undamaged (Brumbaugh, 1990). The two damaged wells are both near the margins of the

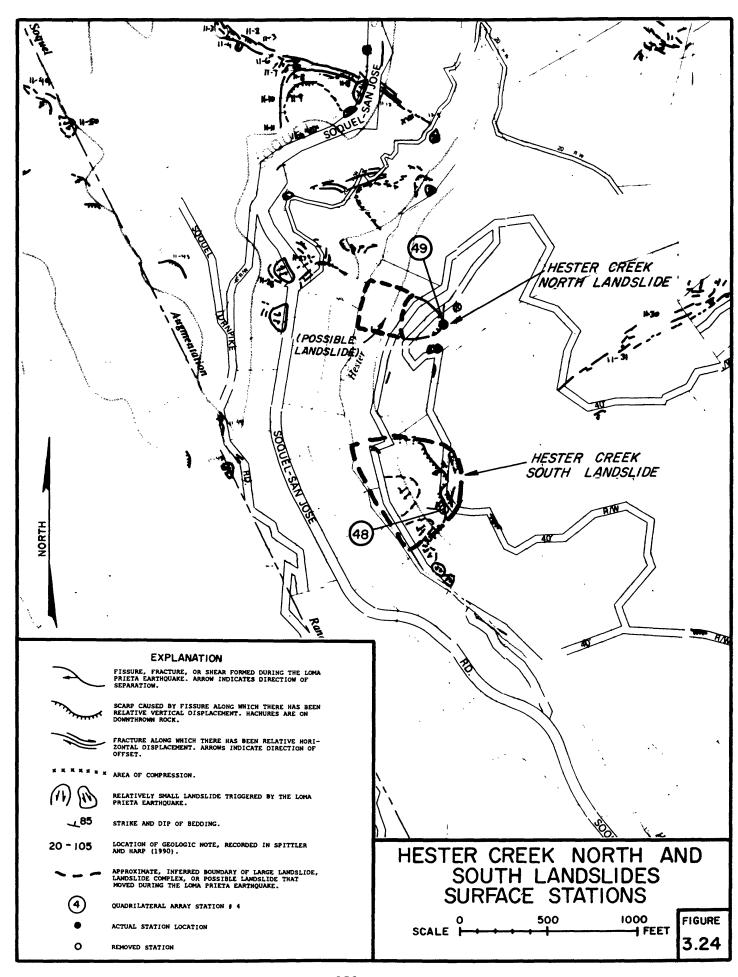
The Hester Creek North landslide is on the eastern bank of Hester Creek, 0.8 miles northwest of the confluence of Hester Creek and Caldwell Gulch and 700 feet east of Old San Jose Road (plate 3.3 and fig. 3.24). The feature interpreted as the main scarp is an almost continuous scarp that is arcuate and concave-downslope and bounds an area approximately 200 feet long and 300 feet wide that covers 1 acre (plate 3.3 and fig. 3.24). The location of the landslide toe is uncertain; the landslide may extend as far downslope as Hester Creek, encompassing an additional 2 acres. Measurements across the main scarp suggested that 12 to 31 inches of downslope displacement had taken place.

The Hester Creek South landslide is on the eastern bank of Hester Creek, 600 feet south of the Hester Creek North landslide. This southern landslide is larger and has a more complex set of cracks and scarps defining its crown, head, and upper flanks (plate 3.3 and fig. 3.24). Included within the landslide area are a nearly continuous main scarp, crown cracks upslope from the main scarp, and at least two internal scarps; these features together with the channel of Hester Creek, which is inferred to be the downslope limit of the landslide, enclose an area, approximately 600 feet long and 600 feet wide, that covers approximately 7 acres. The average slope in the area of this landslide is on the order of 25° to 30°. One measurement at a point on the southern part of the main scarp

(quadrilateral array #48 on fig. 3.24) indicated downslope displacement in the range between 4 and 10 inches. Three smaller landslides adjoin the southern flank of the Hester Creek South landslide (plate 3.3 and fig. 3.24). As with the Hester Creek North landslide, the slope on which the Hester Creek South landslide occurred has produced many previous landslides during periods of winter rainfall (Griggs and others, 1990) and is included in an area underlain by part of a "questionable" landslide deposit, according to the map of Cooper-Clark and Associates (1975; see fig. 3.7).

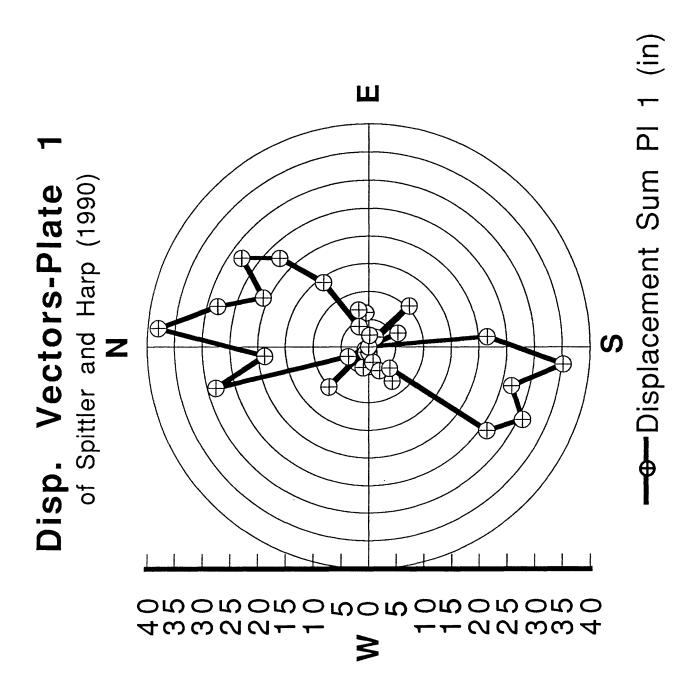
Figure 4.4. Rose diagram showing amounts of dispacement summed from all measurements with a given azimuth across all fractures inferred to be related to regional structure within the area covered by plate 1 of Spittler and Harp (1990).

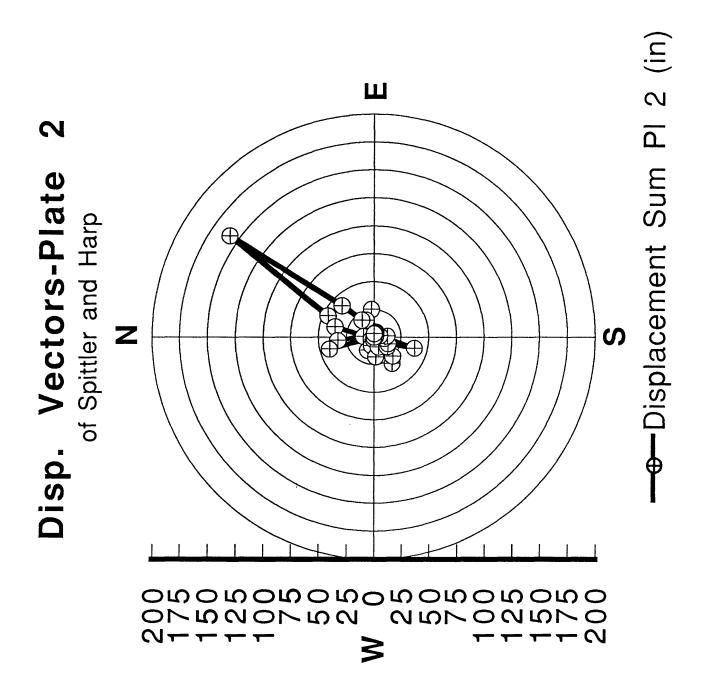
Figure 4.5. Rose diagram showing amounts of dispacement summed from all measurements with a given azimuth across all fractures inferred to be related to regional structure within the area covered by plate 2 of Spittler and Harp (1990).

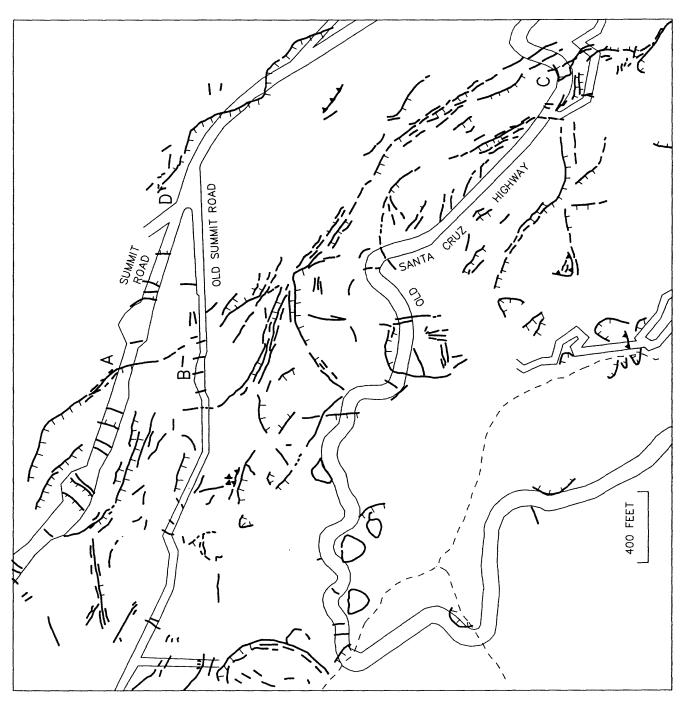
Figure 4.6, a portion of plate 4.1, shows this fracture and several other fractures, approximately parallel and to the southwest, which formed a zone approximately 600 feet wide along Summit Road. To the southeast, this zone was approximately 400 feet wide at Old Summit Road (B in fig. 4.6) and less than 100 feet wide at a point 650 feet farther southeast. Figure 4.6 shows this fracture zone continuing southeastward from this latter point to the southeast, expanding to a 400-foot-wide zone and ending near Old Santa Cruz Highway (C in fig. 4.6). The average trend of this somewhat discontinuous zone of fractures was N45°W. The zone extended for more than 4,000 feet and was thus the longest such zone in the

FIGURE 4.6 —— Ground cracks in part of plate 4.1 in Old Santa Cruz Highway area. Letters indicate specific localities discussed in text. Map symbols are the same as in plate 4.1.

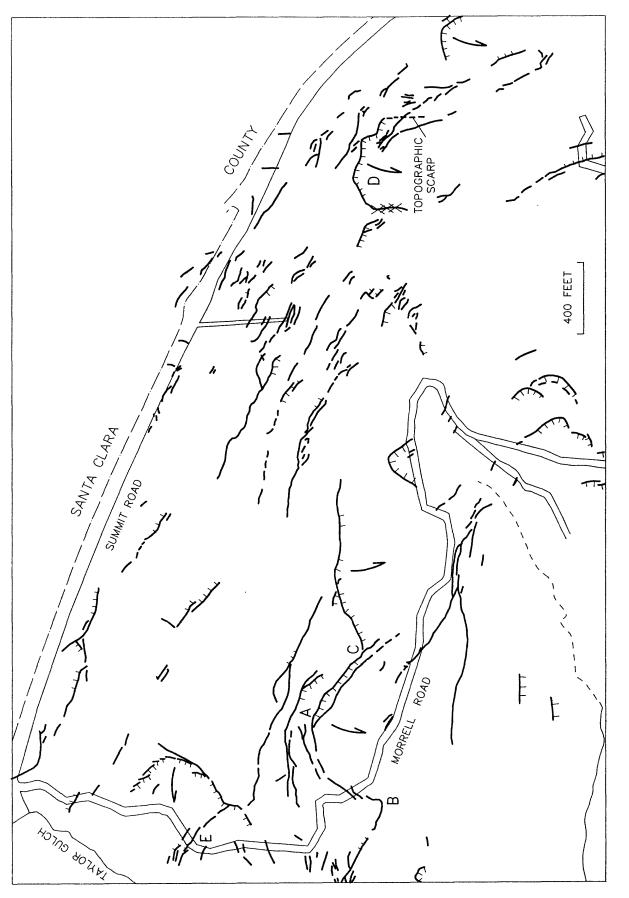
a. Upper Morrell Road landslide: This landslide, on the south flank of Summit Ridge, approximately 1,200 feet east of Taylor Gulch, shows a strong influence of regional structure on the location and shape of fractures forming its margins. Figure 4.7 shows that the zones of fractures forming the main scarp are aligned with fractures along the regional trend (N55°-60°W) for as much as 800 feet.

The fractures that formed the right flank of this landslide curved to the southwest from the main scarp area and trend approximately N20°E where they crossed Morrell Road. At that point, the fractures were predominantly right-lateral with approximately 2 feet of horizontal displacement and 6 to 10 inches of vertical displacement down to the southeast. Approximately 75 feet to the southwest along this fracture zone, its trend abruptly swung clockwise to N60°W (B in fig. 4.7), parallel to the regional structure. Immediately west of this trend change, the fracture became predominantly extensional and several upslope-facing scarp segments were present; maximum displacements on these were 2 inches. At this trend change, the fracture zone ceased to exhibit landslide characteristics and took on the attributes of fractures associated with regional structure.

FIGURE 4.7 —— Ground cracks in part of plate 4.2 in Morrell Road area. Letters indicate specific localities discussed in text. Map symbols are the same as in plate 4.2.

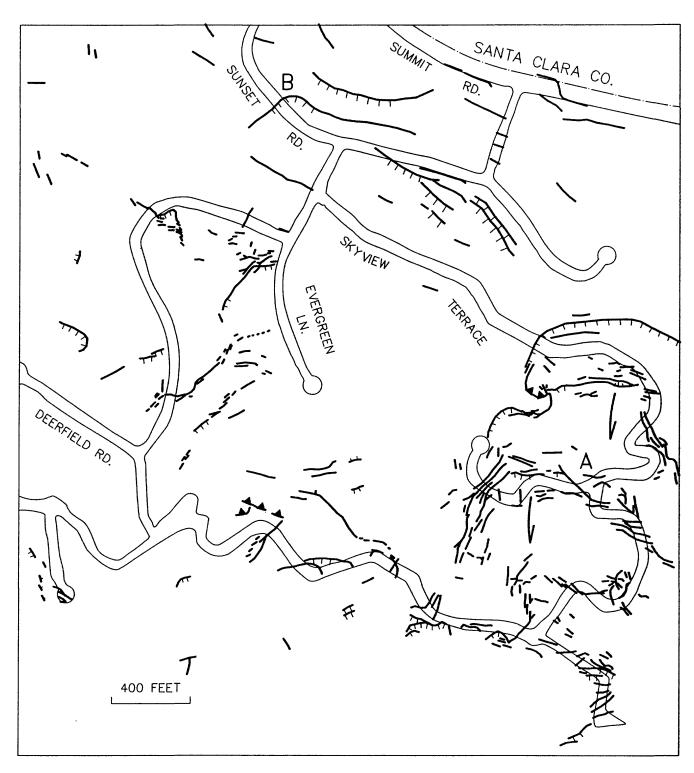
b. Villa Del Monte area: Several zones in the Villa Del Monte area showed the interaction of the regional structure with the development of landslide fractures. Near the junction of Skyview Terrace and Bel Air Court, a fracture zone trending N50°W formed part of an internal landslide scarp (A in fig 4.8). This fracture zone was parallel to the trend of the regional structure. In a manner similar to the Upper Morrell Road landslide, the right flank of this fracture zone curved counterclockwise to the southwest to a trend of about N20°E.

FIGURE 4.8 —— Ground cracks in part of plate 4.1 in Villa Del Monte area. Letters indicate specific localities discussed in text. Map symbols are the same as in Plates 4.1 and 4.2.
